Building Decommissioning Assessment Report

**Former Hangar 2
Willow Run Airport
Ypsilanti, Michigan
Task 3**

**Prepared by/for:
Wayne County Airport Authority**

**MARCH 2014
REF. NO. 081129 (3)**

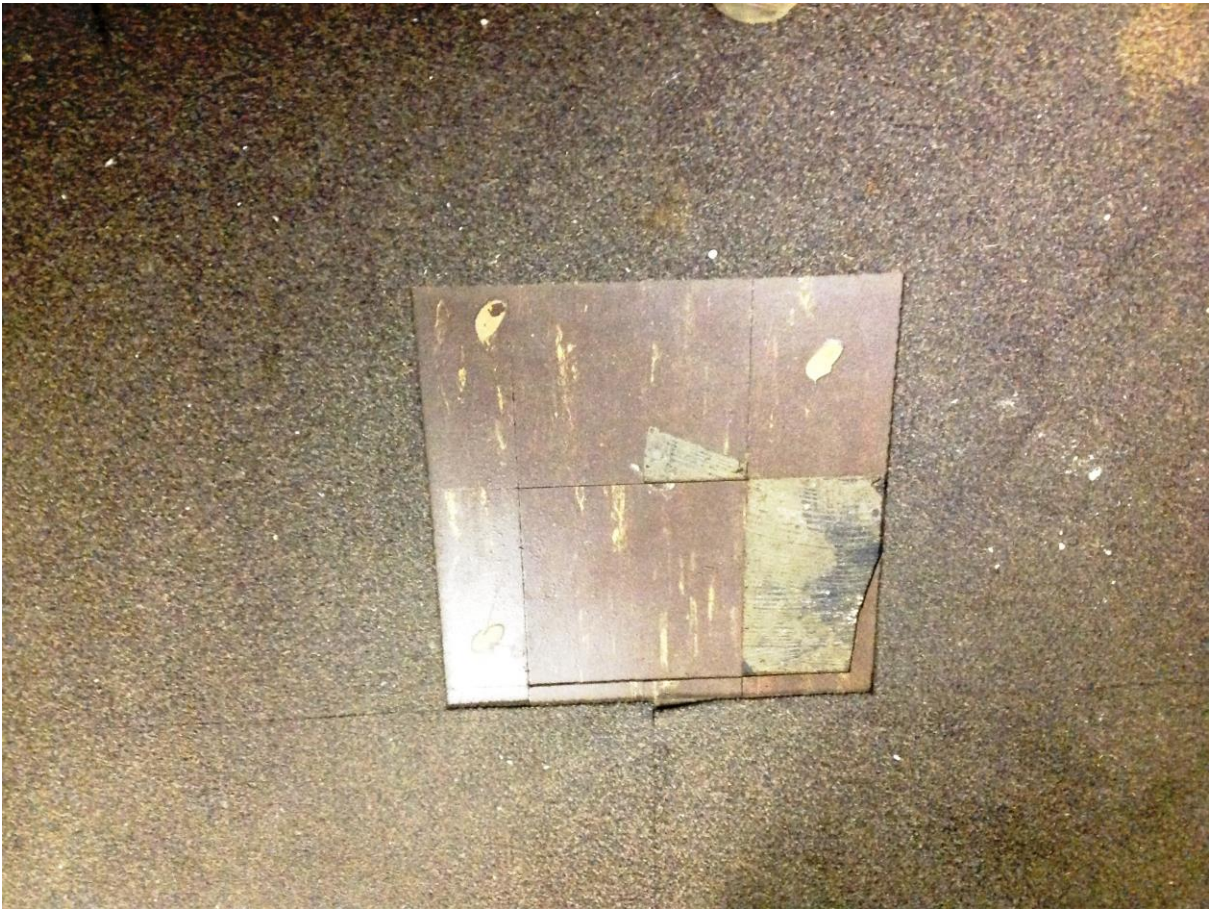
Photo #1: Asbestos-containing 9" x 9" floor tile (brown). Representative for all 9" x 9" tiles.

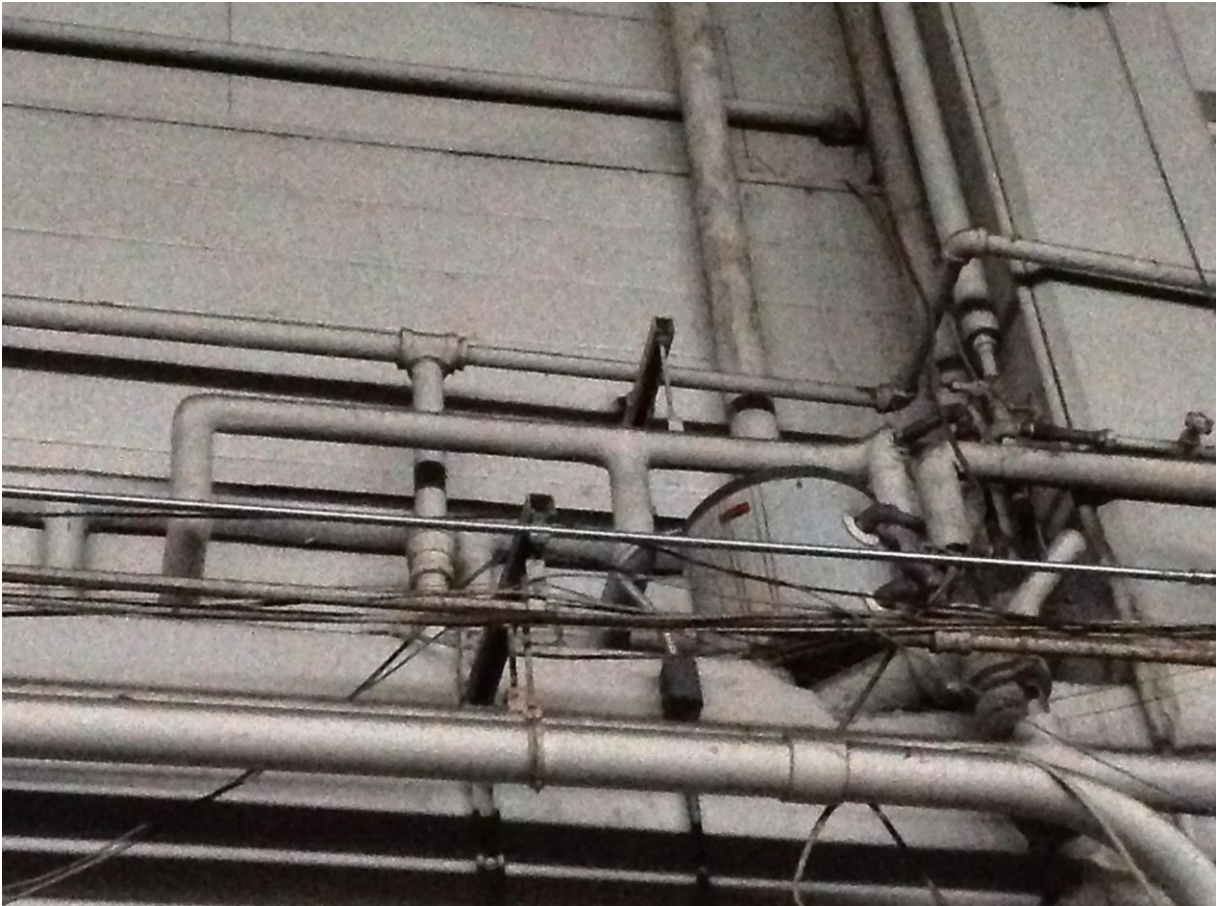
Photo #2: Asbestos-containing thermal system straight pipe/joint insulation (water).

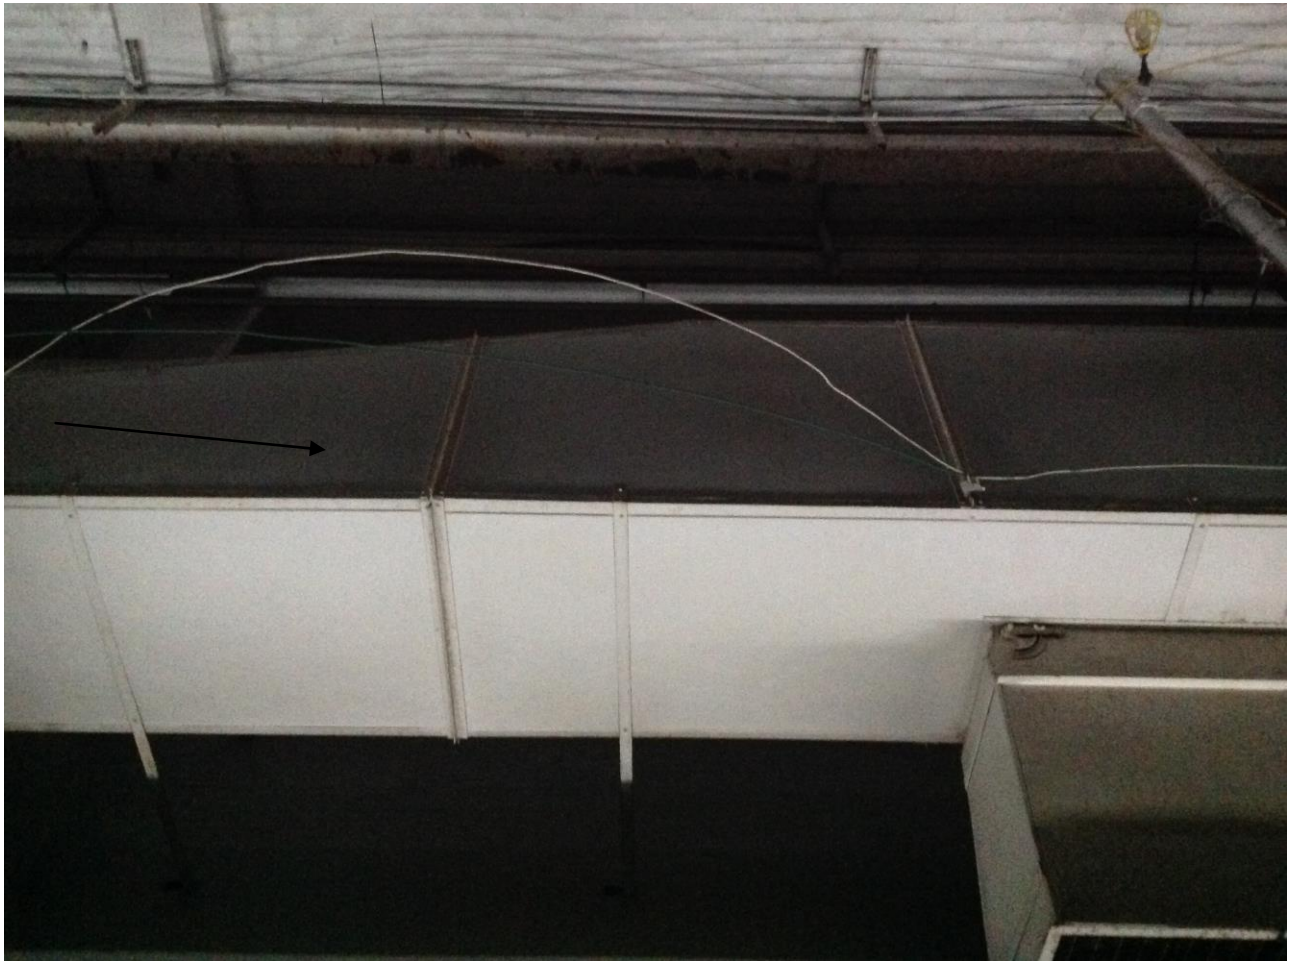
Photo #3: Cement asbestos HVAC duct.

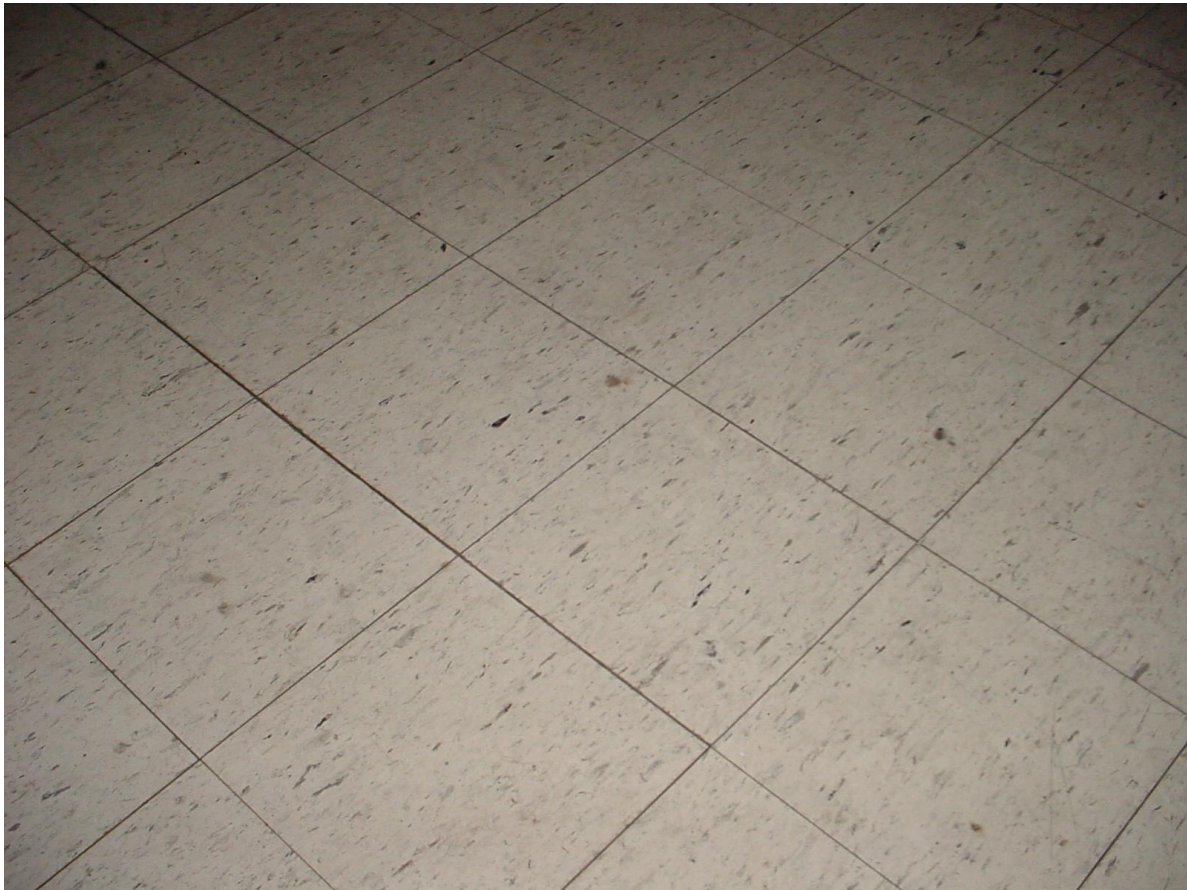
Photo #4: Asbestos-containing 12" x 12" floor tile (off white w/ black flecks).

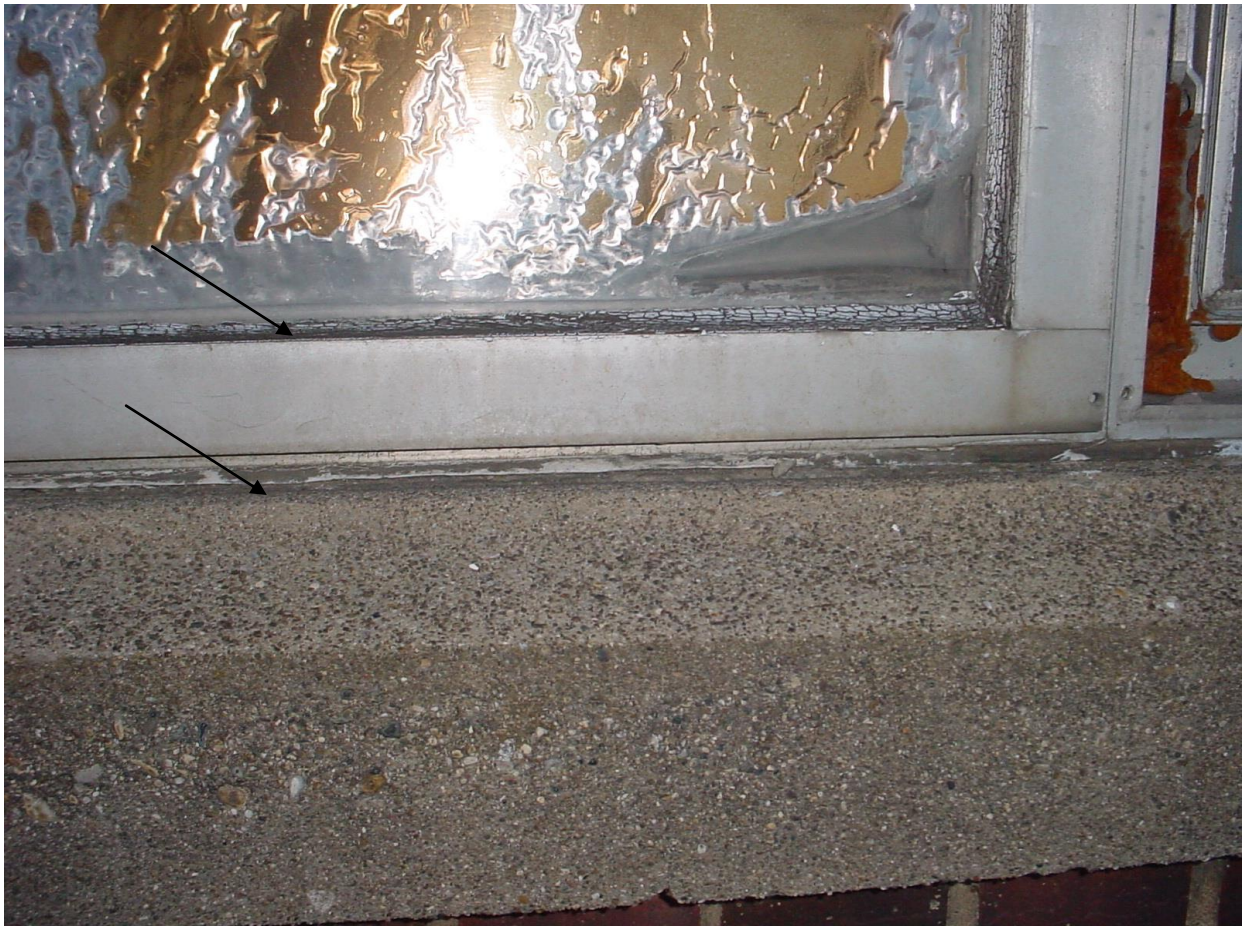
Photo #5: Asbestos-containing exterior window caulks.

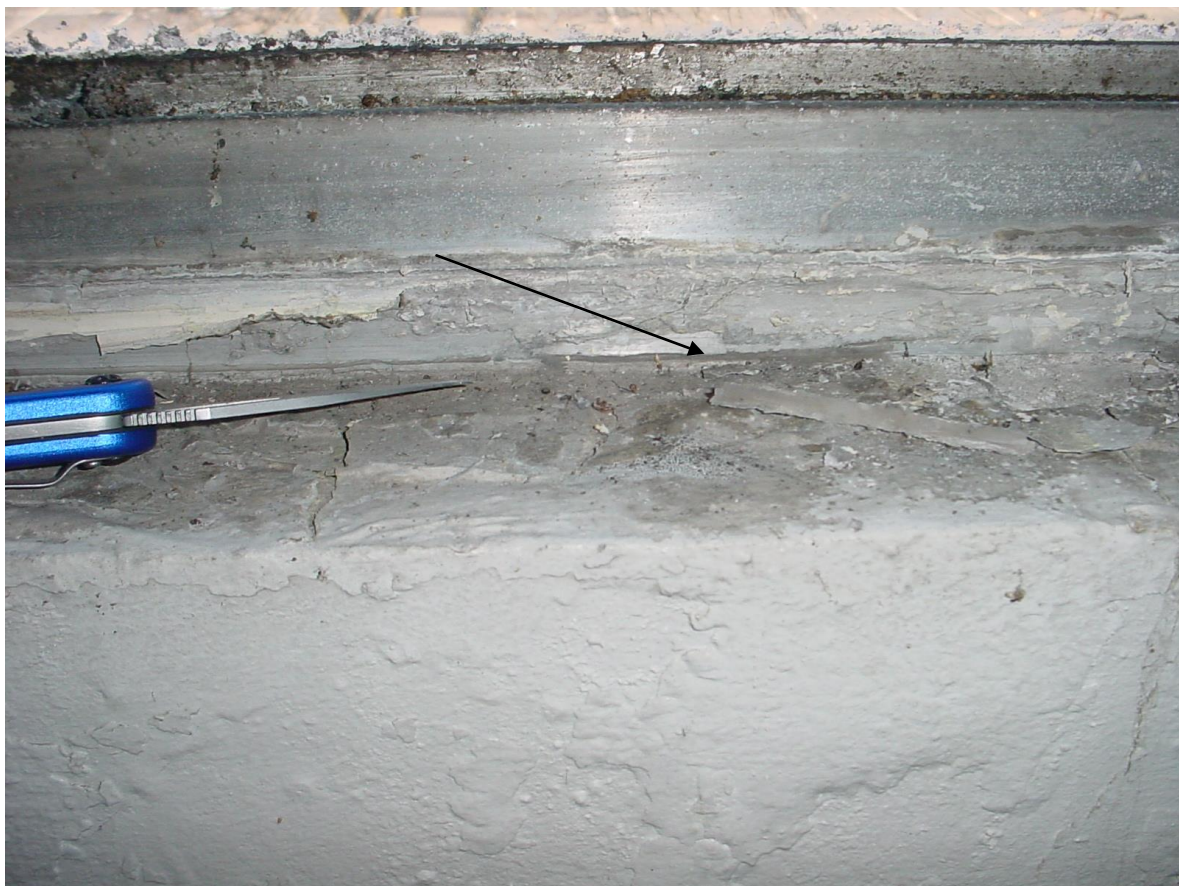
Photo #6: Asbestos-containing interior window glaze.

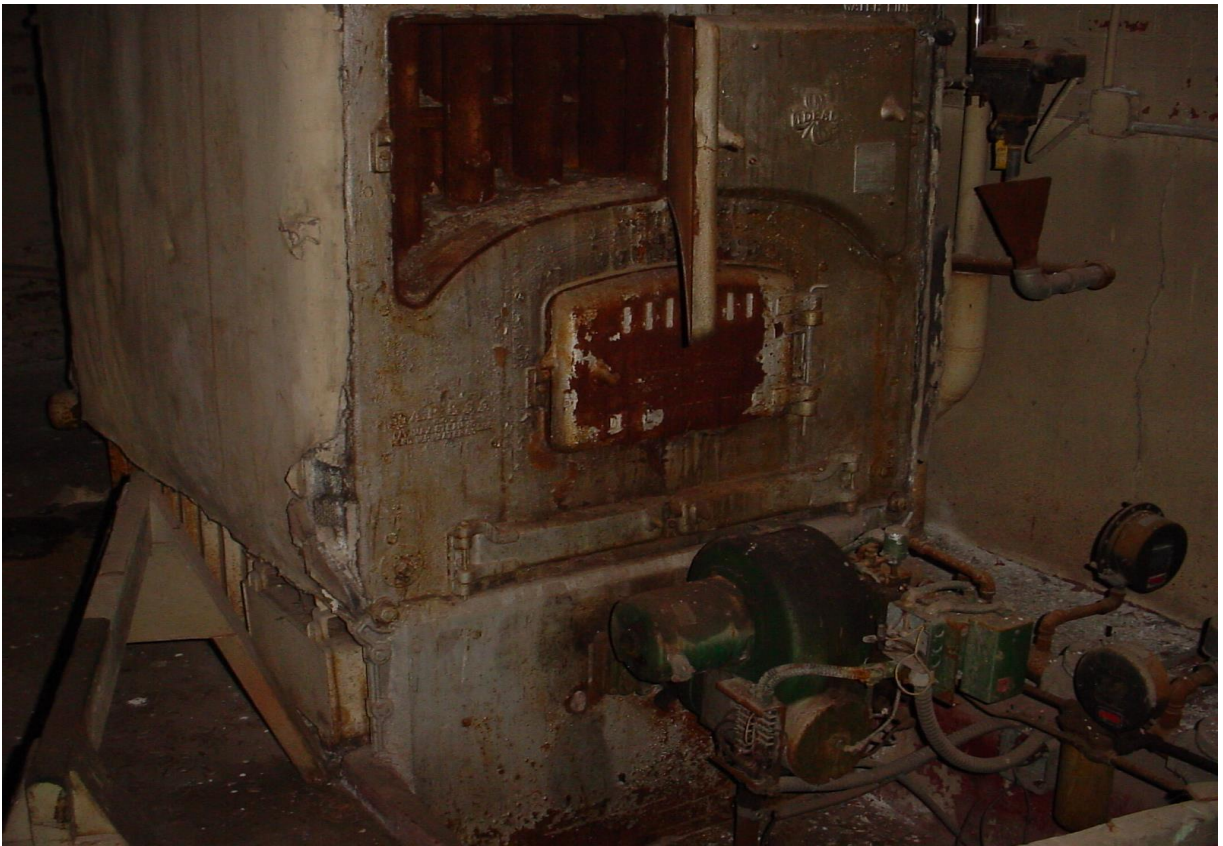
Photo #7: Asbestos-containing Boiler insulation, Bay 2 interior boiler room.

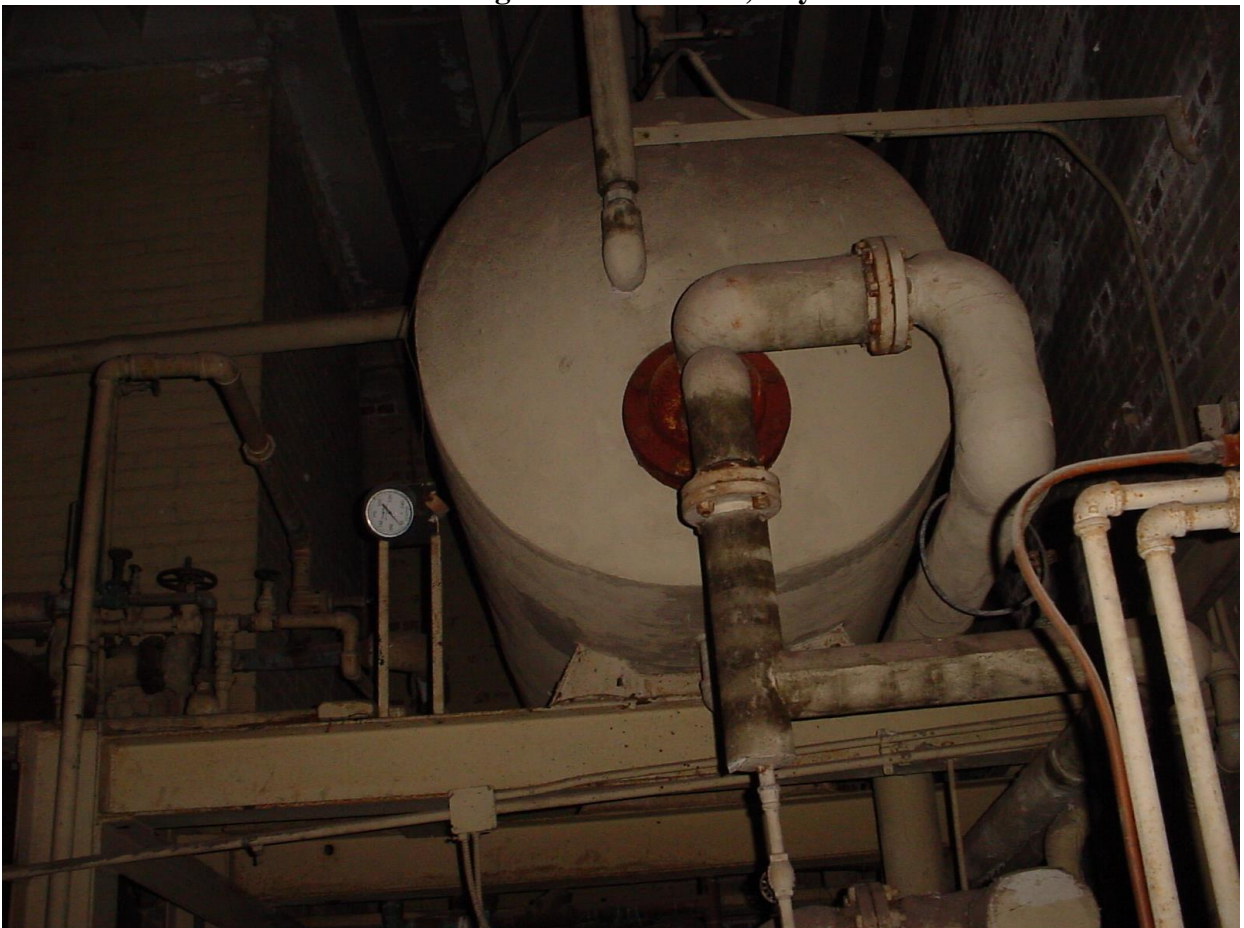
Photo #8: Asbestos-containing HW tank insulation & heating piping, Bay 2 interior boiler room.

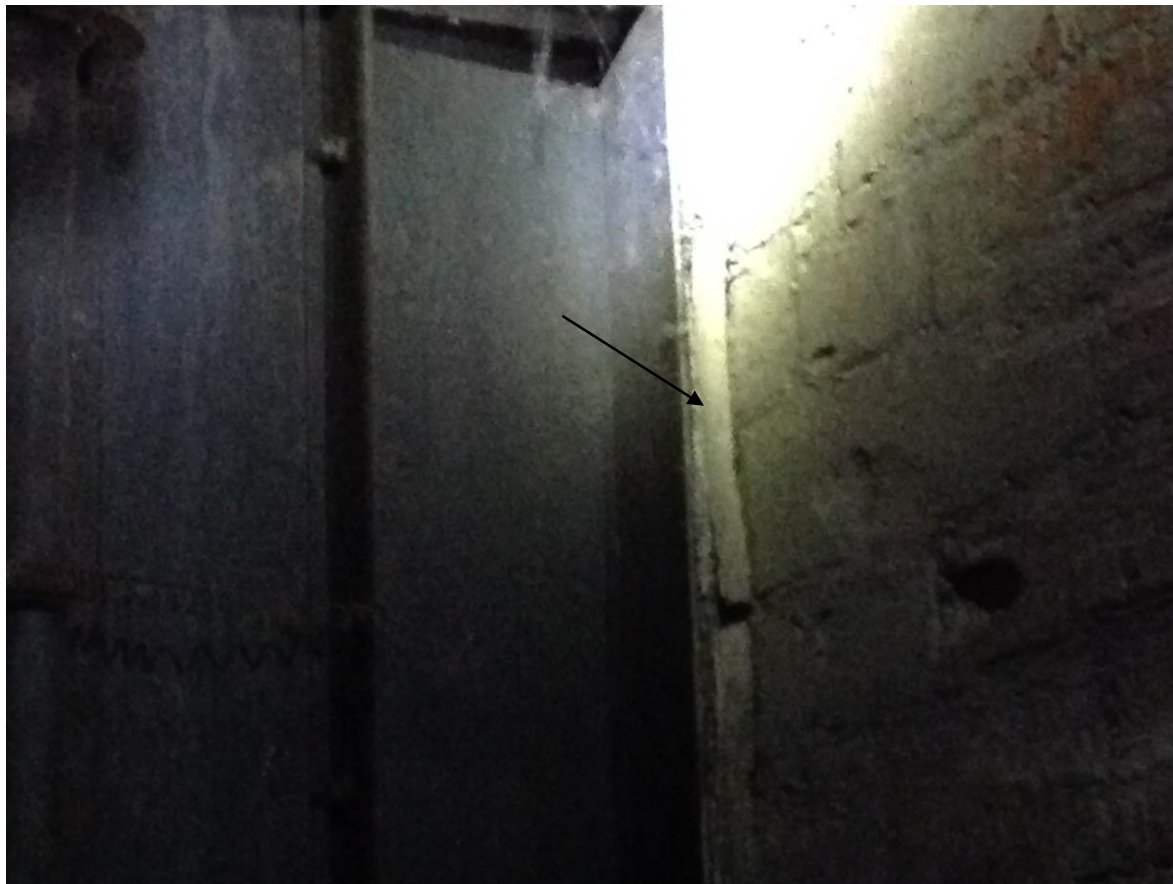
Photo #9: Asbestos-containing boiler caulk/gasket.

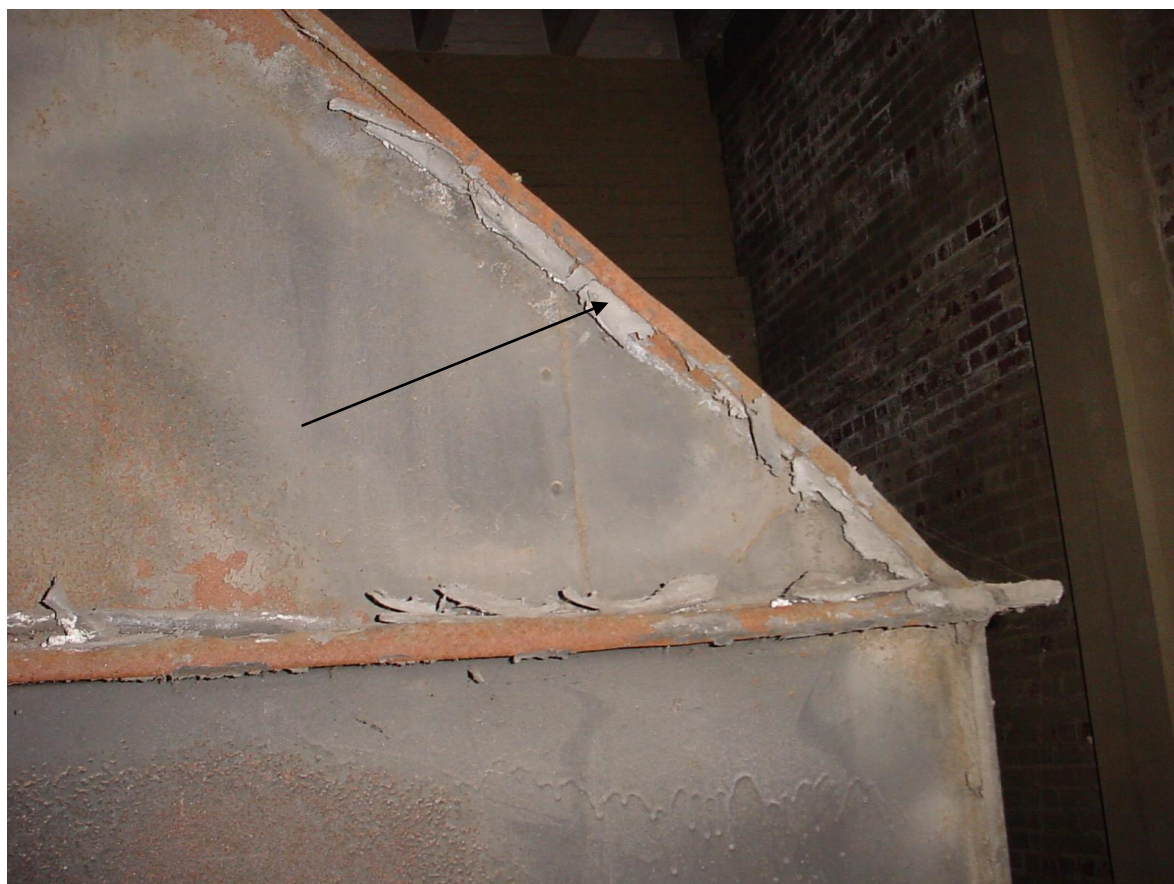
Photo #10: Asbestos-containing fan unit caulk.

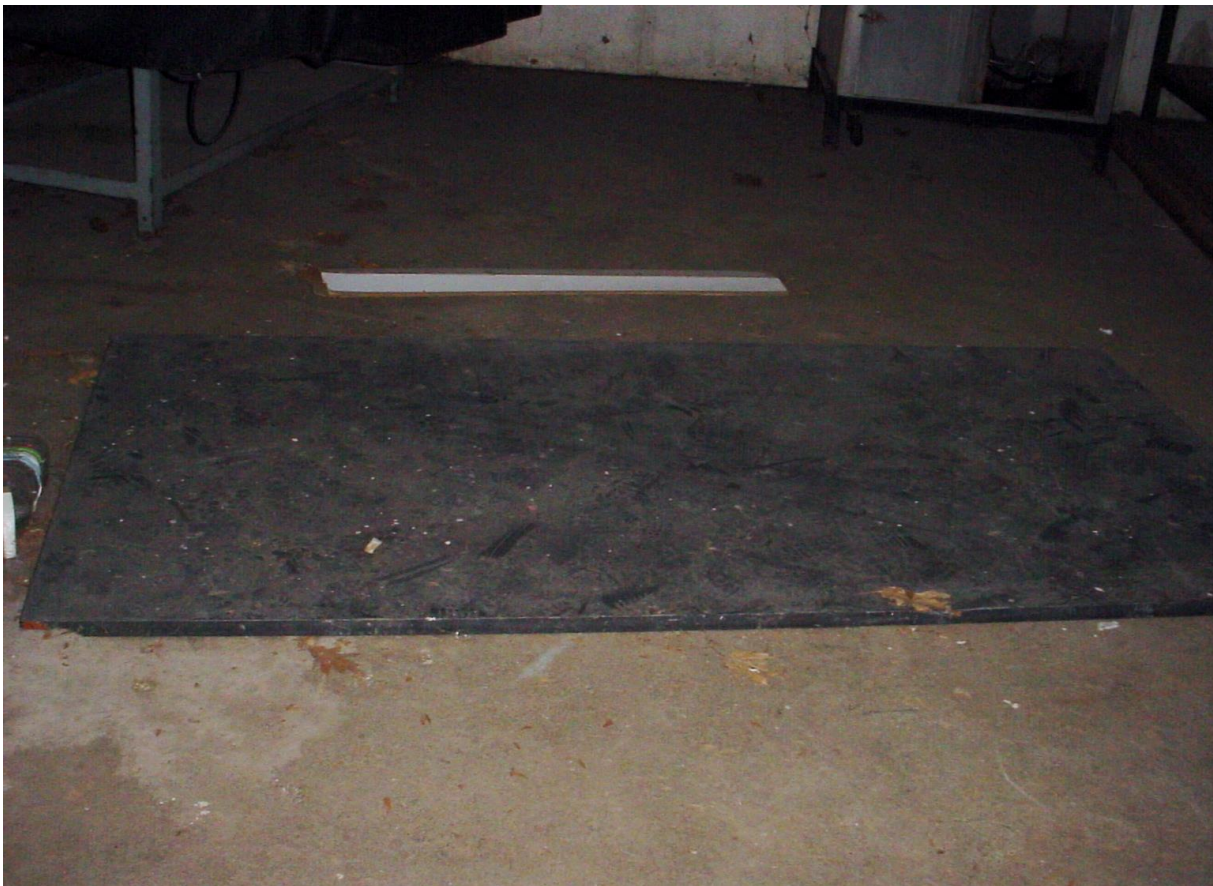
Photo #11: Asbestos-containing lab table top.

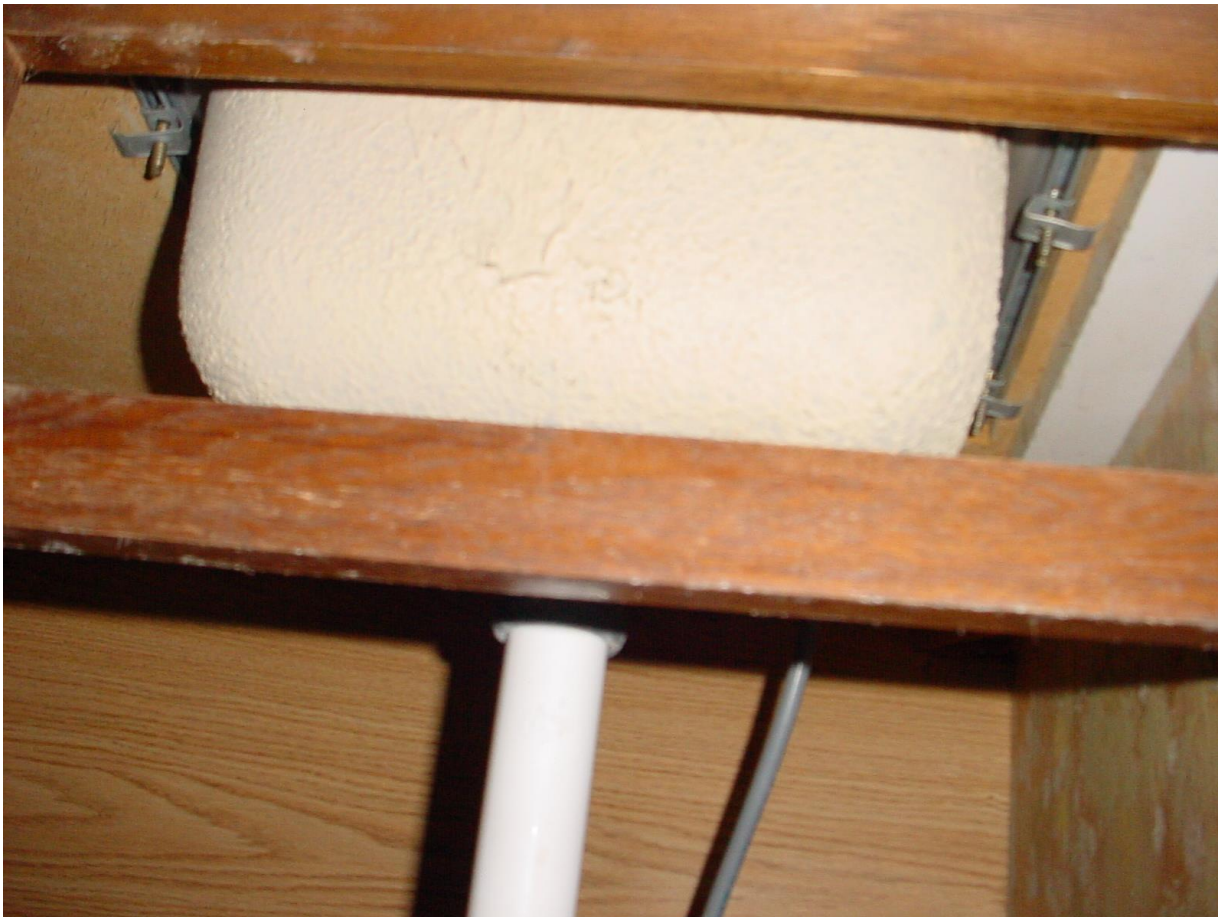
Photo #12: Asbestos-containing white sink insulation.

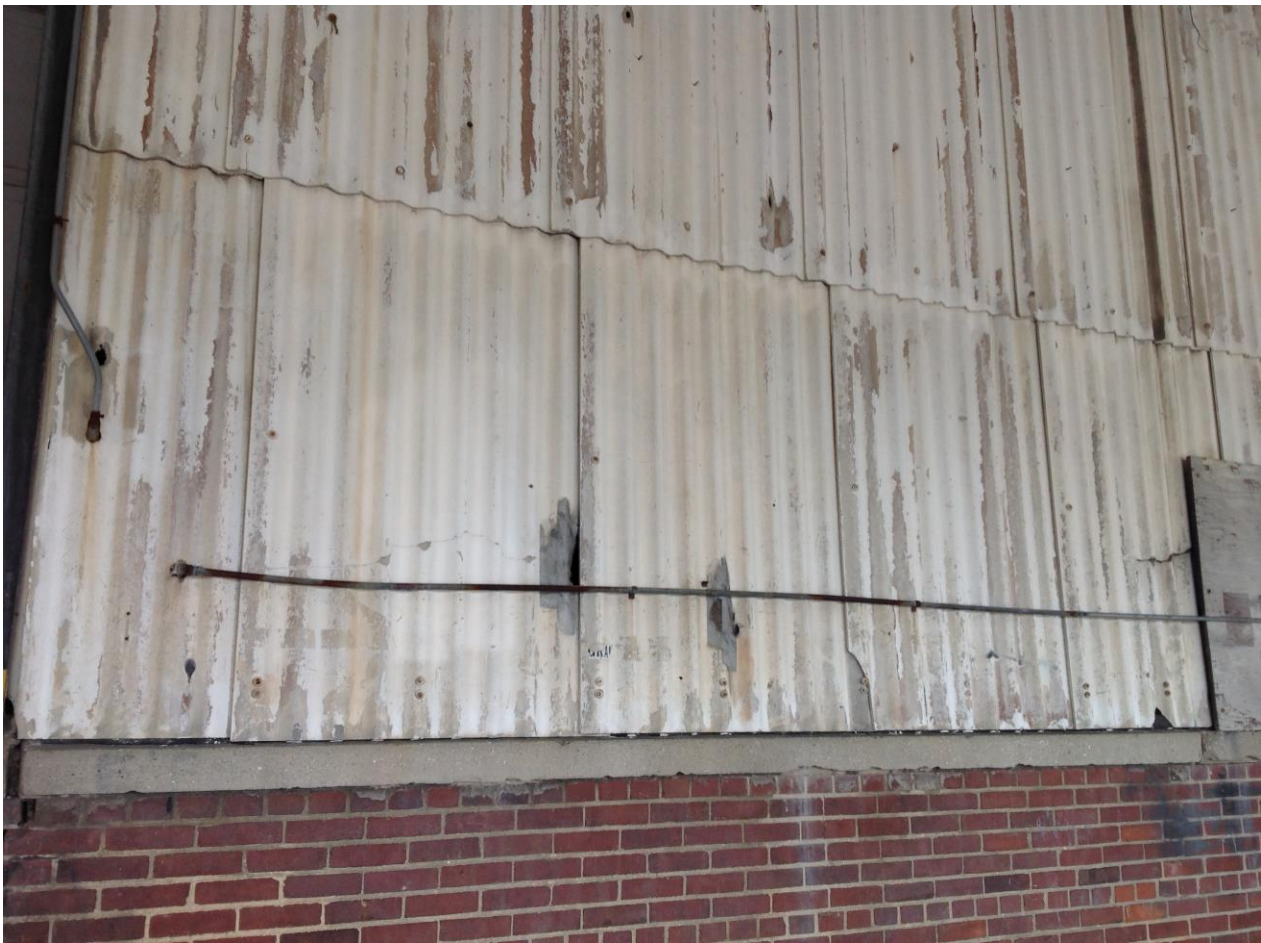
Photo #13: Exterior cement asbestos corrugated panels.

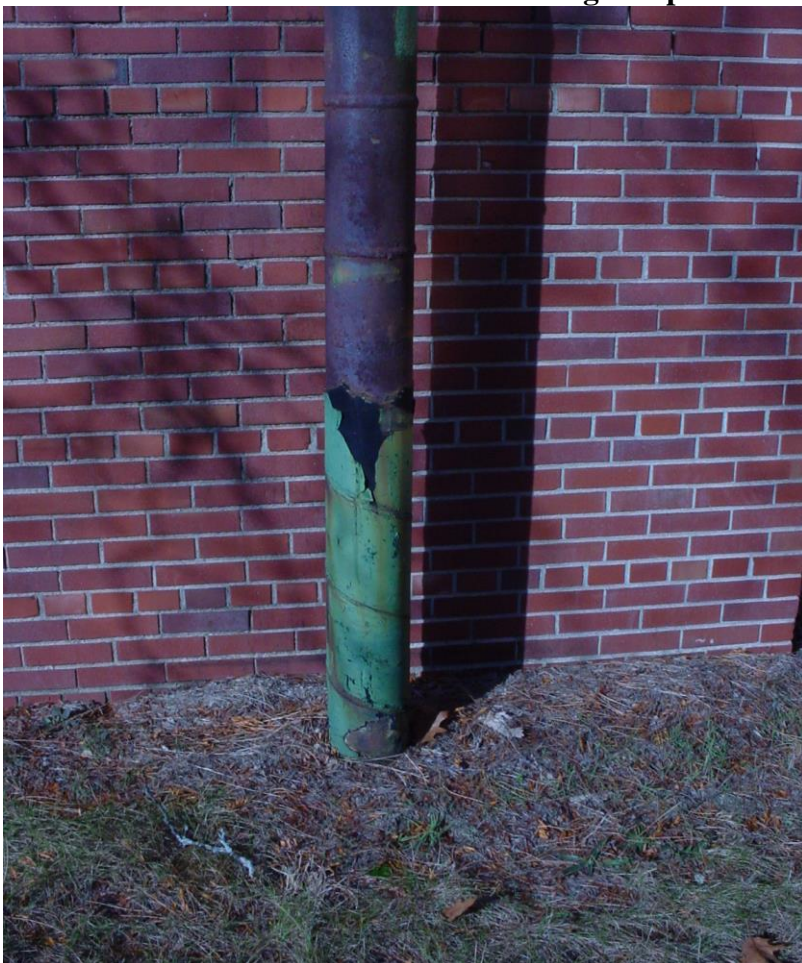
Photo #14: Asbestos-containing exterior fuel line pipe insulation.

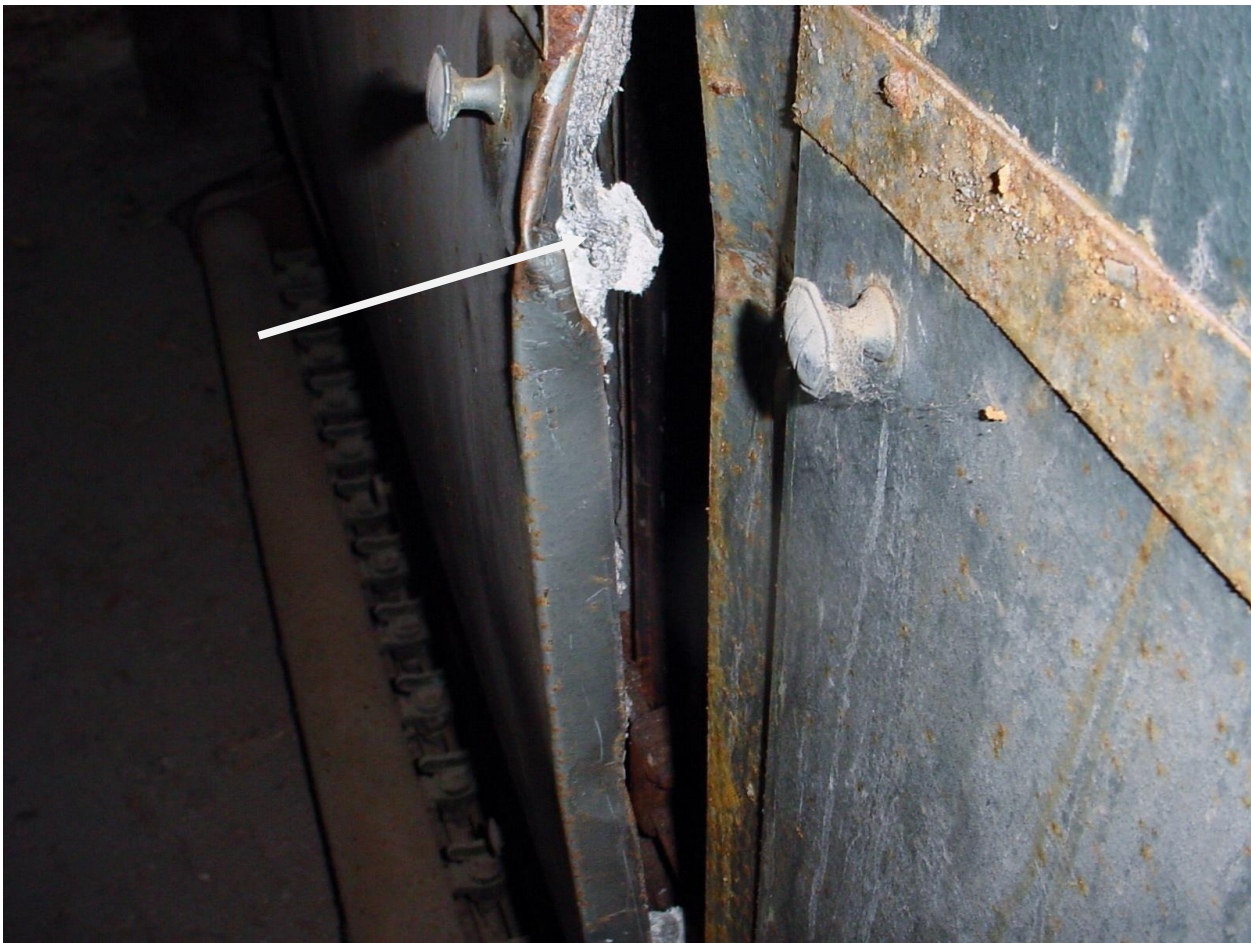
Photo #15: Asbestos-containing boiler wall insulation. Exterior boiler room, Bay 6.

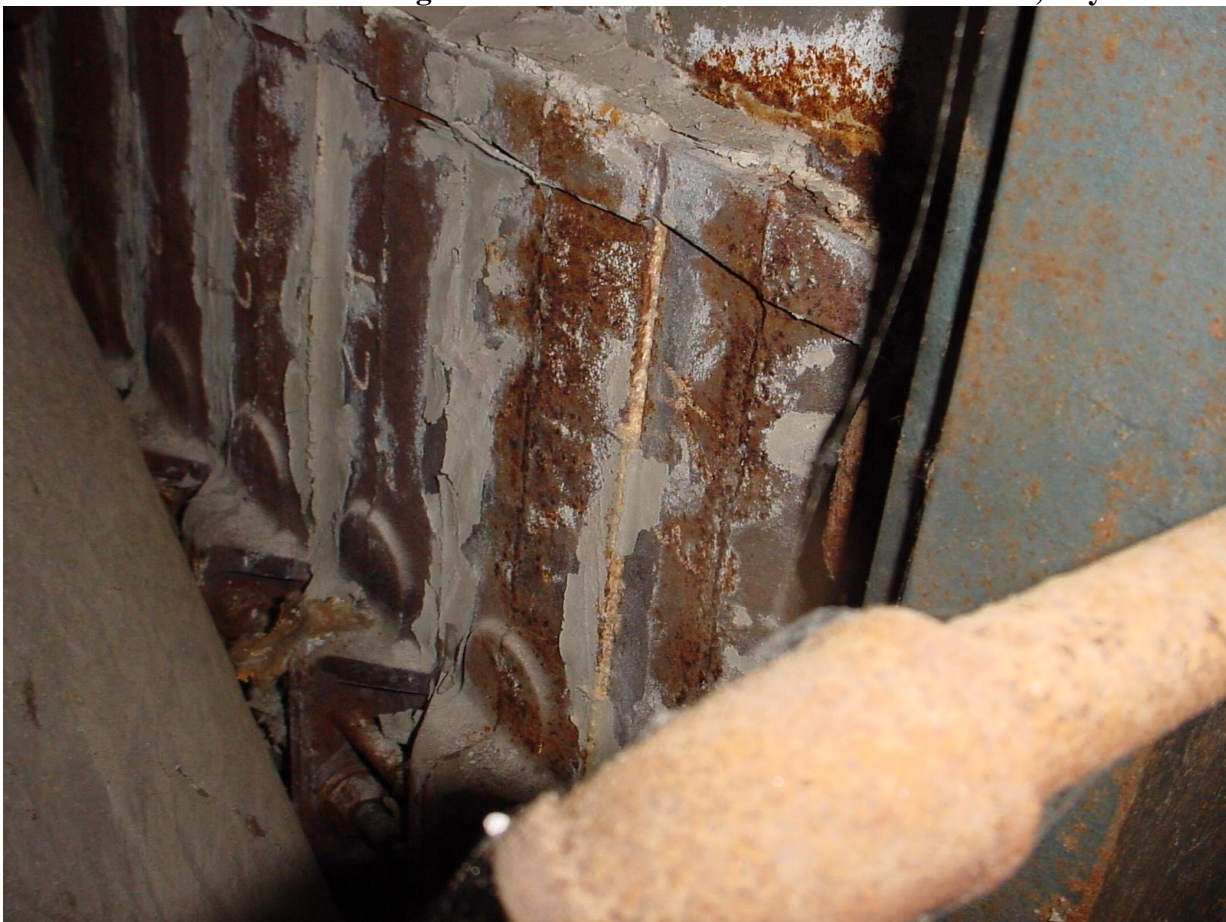
Photo #16: Asbestos-containing boiler plate mud. Exterior boiler room, Bay 3.

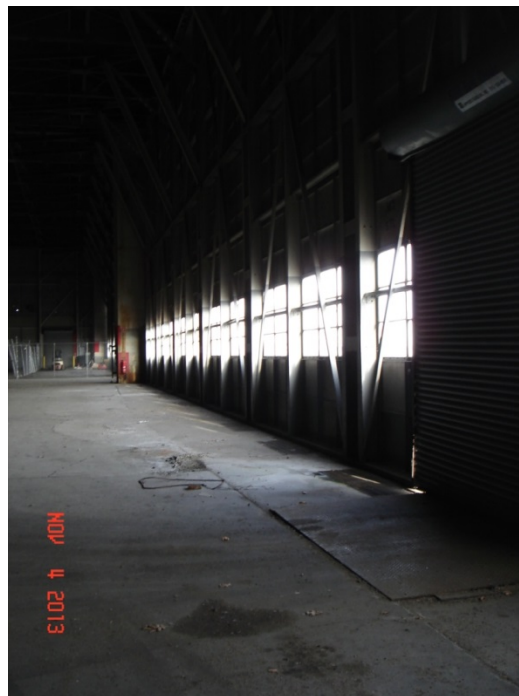
A floor trench was observed in the main hangar running the length of the hangar doors. This trench system is part of a building exhaust system constructed below slab grade. No debris was visible in this trench system and it was not sampled as part of the BDA.

Photo 4 – Hangar 2 HVAC trenches and hangar doors

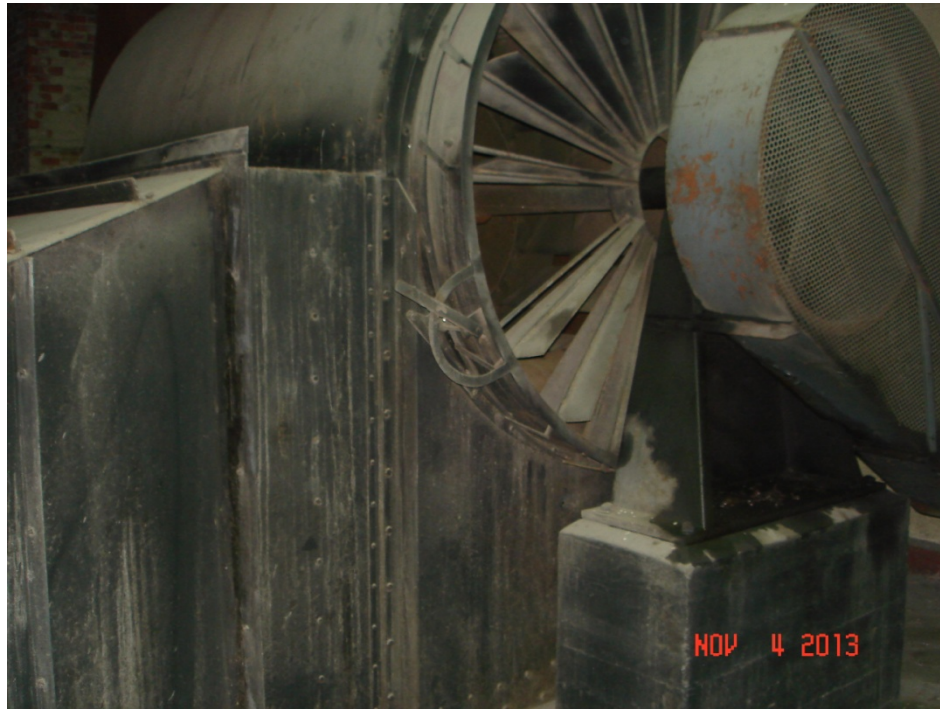
CRA observed visible oil on equipment. This included air compressor equipment and axles associated with the motors and fans of the ventilation equipment. Wipe samples (Samples 026, 029 and 034 – 041) were collected of these oil stained metal surfaces. These samples were analyzed for PCBs. PCB results for the samples were compared to the 40 CFR 761.61(a) criteria for nonporous surfaces located in high occupancy areas of less than or equal to $10 \mu\text{g}/100\text{cm}^2$. PCBs were not detected at concentrations exceeding $10 \mu\text{g}/100\text{cm}^2$ in these wipe samples (Table 6).

Photo 11 – Hangar 2 boiler fan oil leak

5. Upon confirmation of de-energization of transformers, additional transformer oil, cable, and component sampling is recommended.
6. Equipment with fluids and oils must be drained prior to demolition. These fluids must be characterized and properly disposed.

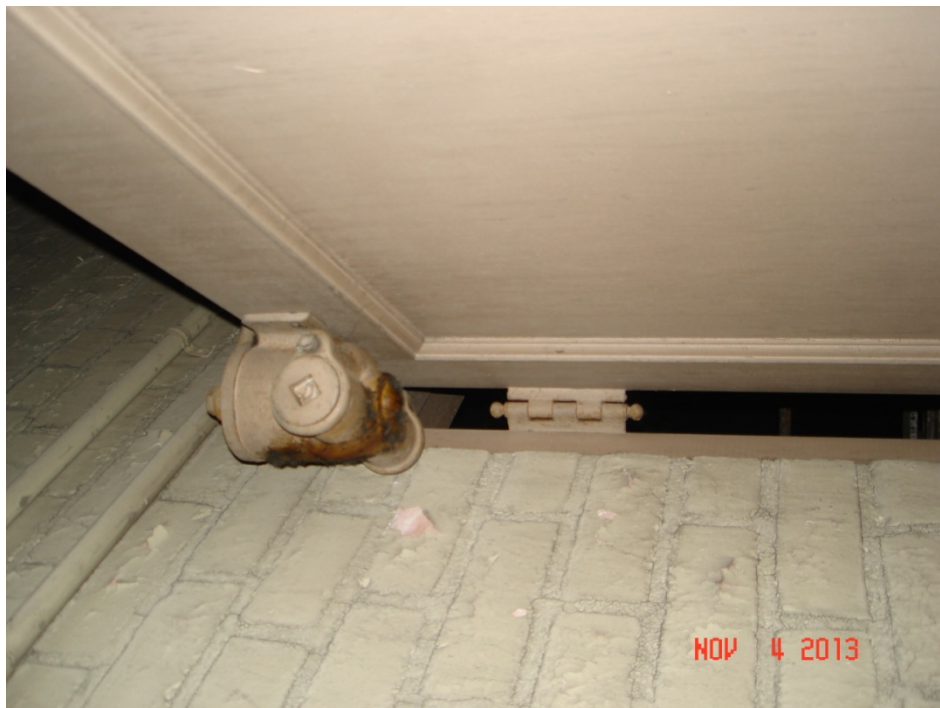
Oil was found in vintage door hinge dampeners and sampled for PCBs (Samples 056 and 057). All PCB results for these oil samples were below detection. The results for these oil samples are reported in Table 5.

Photo 12 – Hangar 2 typical door reservoir

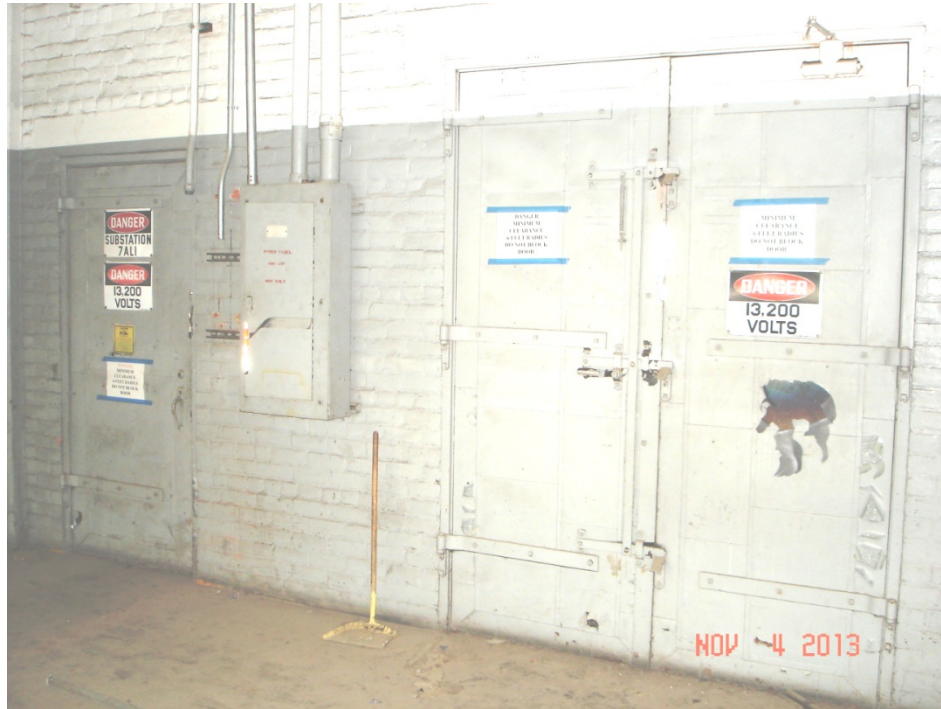
Photo 21 – Hangar 2 central east wall active substation

4. One substation with a connected exterior switchgear room was identified in Hangar 2 during BDA activities. The electrical equipment, concrete slab, and walls must be removed and disposed of as Toxic Substances Control Act (TSCA) wastes during decommissioning. Additional delineation sampling of the exterior concrete and soils surrounding the switchgear room is required once weather and surface conditions are favorable for proper sample collection.

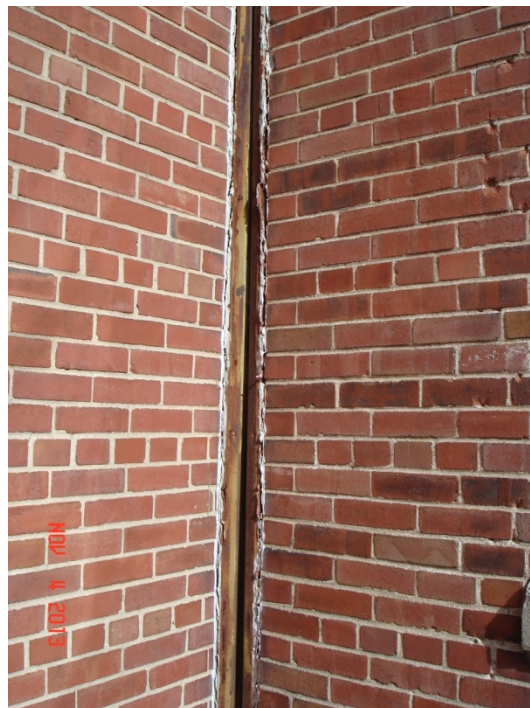
Photo 24 – Hangar 2 east side wall expansion joint

Although the PCB concentrations in the expansion joint materials are less than 50 mg/kg and not regulated for disposal by TSCA, CRA recommends these materials be removed during decommissioning and disposed as demolition debris. Expansion joint materials were collected from building interior, exterior, floors, and walls. These materials should not be allowed to be crushed with concrete intended

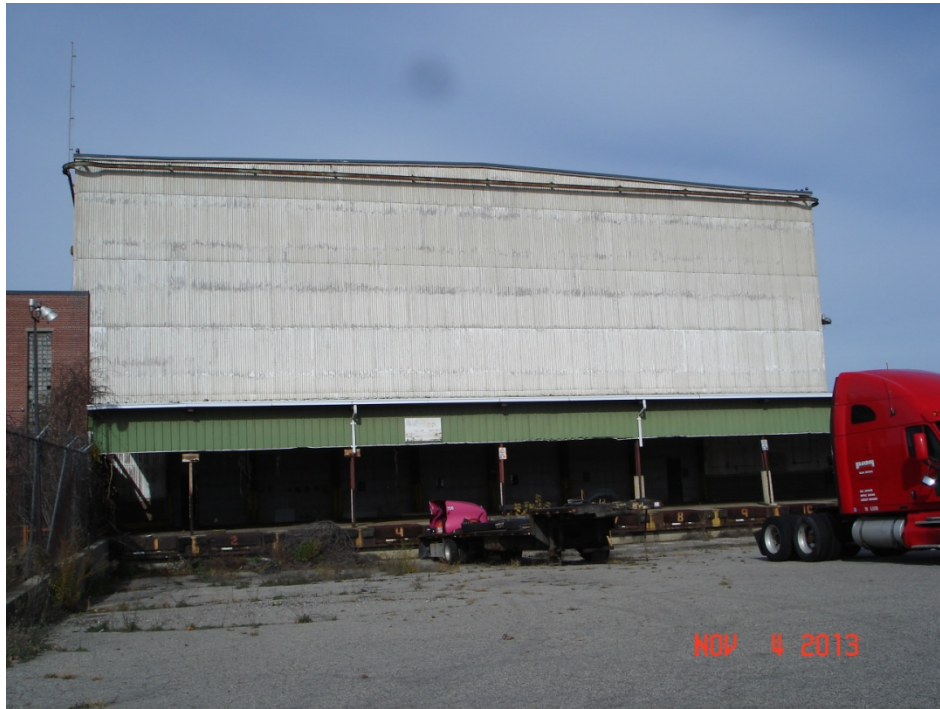
Photo 25 – Hangar 2 south side transite siding
